PUBLIC ROADS

JOINTS AND CRACKS IN CONCRETE PAVEMENTS

A COOPERATIVE STUDY BY PUBLIC ROADS ADMINISTRATION AND THE MICHIGAN STATE HIGHWAY DEPARTMENT

Reported by EARL C. SUTHERLAND, Senior Highway Engineer

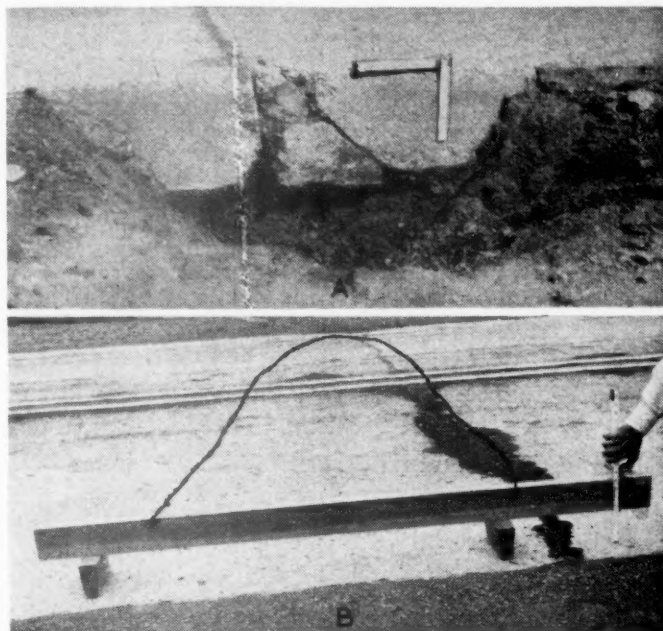
FIGURE 3.—A, SHOULDER REMOVED FOR INSPECTION OF EXPANSION JOINT; B, DEVICE FOR MEASURING FAULTING AT JOINTS AND CRACKS.

Figure 3, A shows the method of exposing the joints for study. It was not practical to expose all of the joints as shown, but this was the general procedure followed. Some joints were examined in more detail than others.

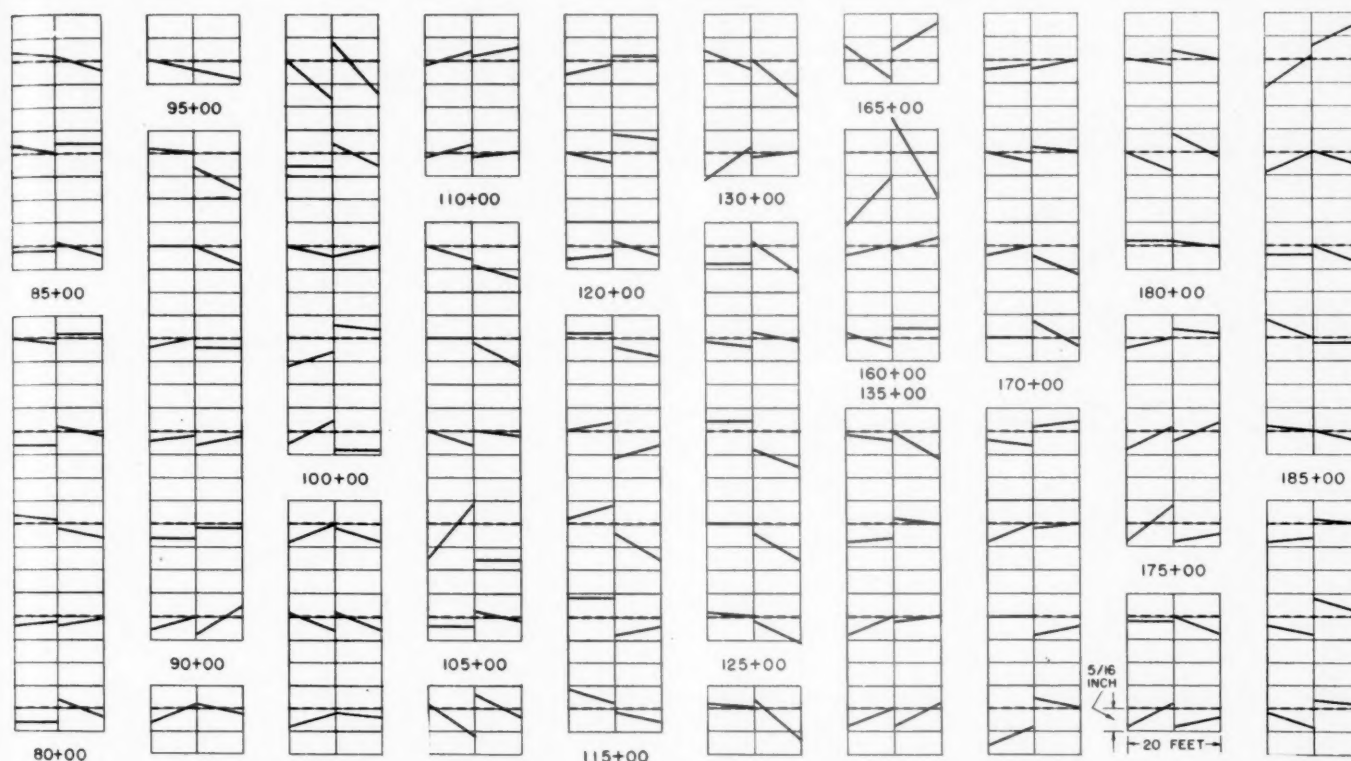
FIGURE 4.—TYPICAL FAULTING MEASUREMENTS SHOWING THE VERTICAL POSITION OF THE SLAB BEYOND THE JOINT WITH RESPECT TO THE APPROACH SLAB IN THE DIRECTION OF TRAFFIC.

Typical data showing the magnitude and direction of faulting at a number of the joints on a two-lane pavement are shown in figure 4. The points at which faulting was measured on two-, three-, and four-lane pavements and the numbers identifying the points are shown in figure 5. Figure 4 indicates the vertical position at the different points on the slab beyond the

joint with respect to the approach slab. Thus, a minus value at a given point indicates that, at this point, the slab beyond the expansion joint is below the approach slab. A positive value indicates the opposite condition.

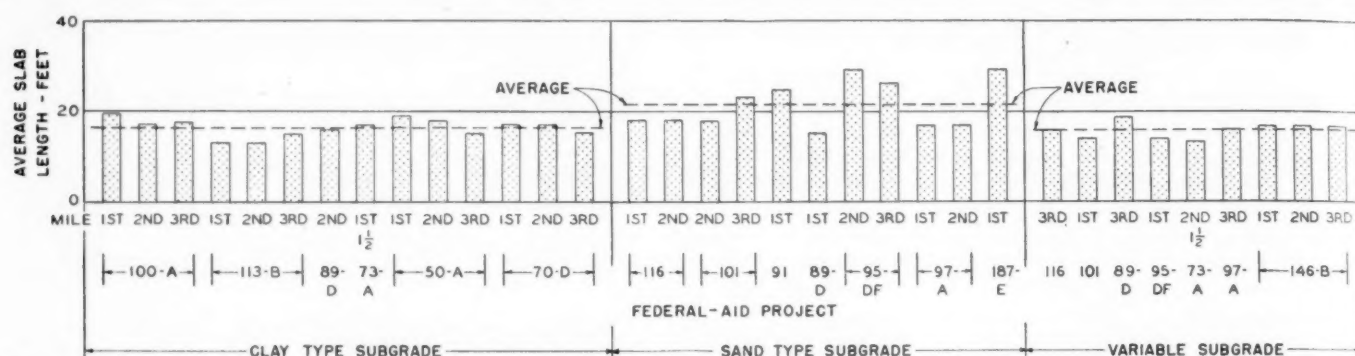
FIGURE 12.—COMPARISON OF THE AVERAGE SLAB LENGTHS OF PAVEMENTS ON DIFFERENT TYPES OF SUBGRADES. THESE PAVEMENTS RANGE IN AGE FROM 12 TO 15 YEARS, WITH THE EXCEPTION OF 187-E WHICH IS 20 YEARS OLD.

Figure 12 shows an average slab length of approximately 16 feet on both the clay and the variable type subgrades, while that on the sandy material was approximately 21 feet. Thus the average slab length on the sandy soils was approximately 30 percent greater than that on the clay soils. It is noted that the average slab length for project 187-E was greater than that on any other project. This was probably the result of favorable subgrade conditions and the removal of some of the poorest sections of the pavement before the survey was made.

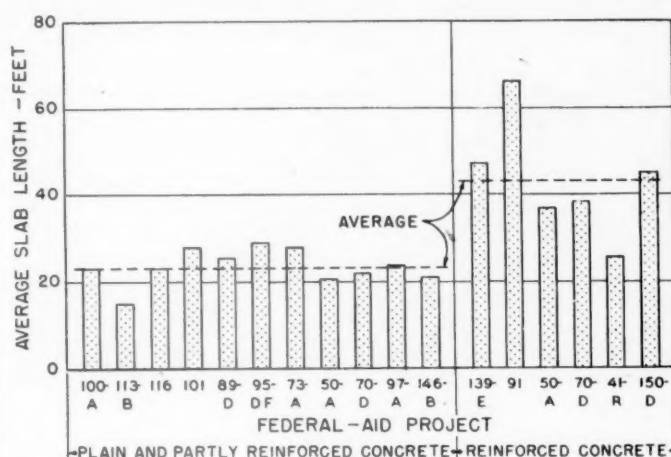
A comparison is made between the average slab lengths of plain and reinforced pavements in figure 16. The reinforced pavements available for this comparison ranged in age from 5 to 7 years and had an average age of 6½ years. The average slab lengths of the plain concrete pavements were taken from figures 10 to 11 at the corresponding age of 6½ years.

FIGURE 16.—COMPARISON OF THE AVERAGE SLAB LENGTHS ON PLAIN AND REINFORCED CONCRETE PAVEMENTS. THE REINFORCED PAVEMENTS VARY IN AGE FROM 5 TO 7 YEARS AND HAVE AN AVERAGE AGE OF 6.3 YEARS. THE AVERAGE SLAB LENGTHS OF THE PLAIN CONCRETE PAVEMENTS WERE TAKEN AT A CORRESPONDING AGE. THE REINFORCED PAVEMENTS WERE REINFORCED WITH A 60-POUND WIRE FABRIC.

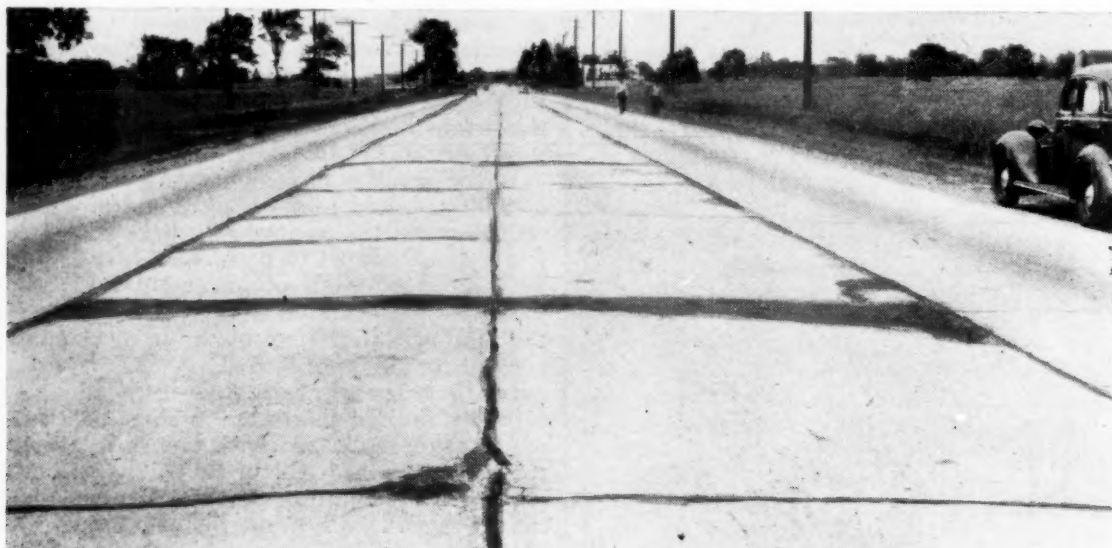
FIGURE 18.—A SECTION OF PAVEMENT TYPICAL OF THOSE STUDIED.

A pavement typical of those studied is shown in figure 18. The inside lanes of this highway were approximately 13 years old and the outside lanes were approximately 4 years old.
